# Manhole Inspection Summary

Manhole # S47C\_\_041MH

Insp Date: **7/14/08 9:03 AM**

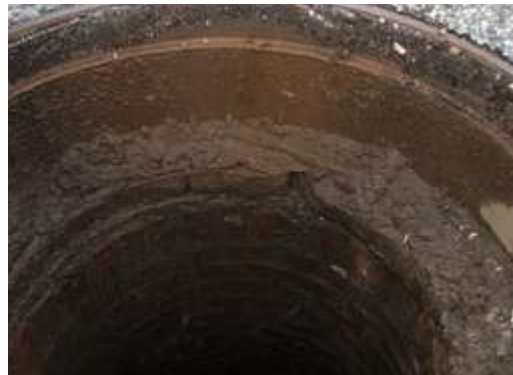
Defect 1

☒ **Leaks**

frame leaks

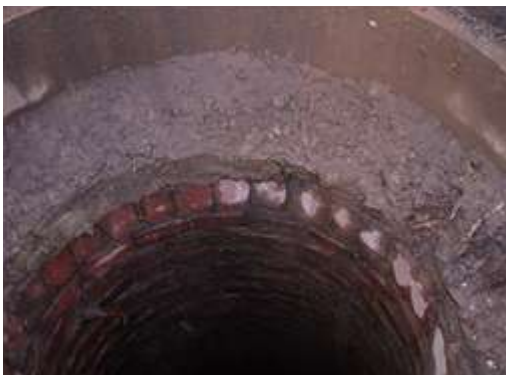
Defect 2

Infiltration: ☐ None ☒ **Joint** ☐ Cracks ☐ Mortar ☐ Roots ☐ Wall

Infiltration: ☐ None ☐ Joint ☐ Cracks ☐ Mortar ☐ Roots ☒ **Wall**

infiltration

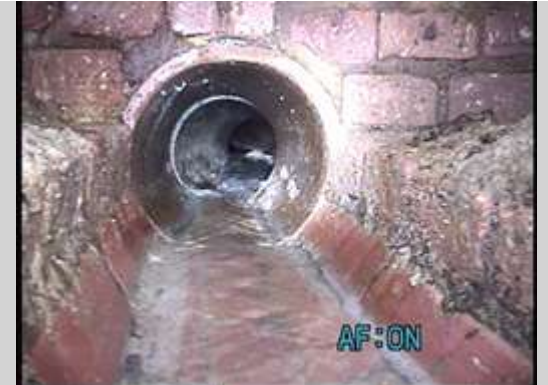
12 O'Clock Outflow

8 in. Circular Gravity Sewer  
Pipe Out @ 12 O'Clock

Pipe Height: **8.4** (in.) Rod and Bar (Angled)  
Pipe Material: **Clay** ☐ Pipe Lined  
Invert Depth: **10.80** (ft.) Flow Characteristics: **Fast**  
Deposits: ☒ None ☐ Mud ☐ Sludge ☐ Debris ☐ Grease  
Silt Depth: (in.) Deposits Extent:  
Infiltration: **None** Pipe Seal Cond: **Sound**

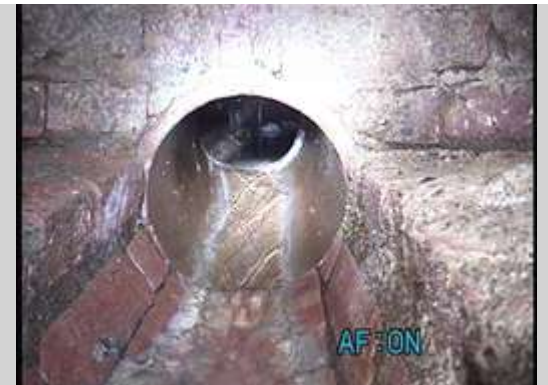
6 O'Clock Inflow

8 in. Circular Gravity Sewer  
Pipe In @ 6 O'Clock

Pipe Height: **8.4** (in.) Rod and Bar (Angled)  
Pipe Material: **Clay** ☐ Pipe Lined  
Invert Depth: **10.75** (ft.) Flow Characteristics: **Fast**  
Deposits: ☒ None ☐ Mud ☐ Sludge ☐ Debris ☐ Grease  
Silt Depth: (in.) Deposits Extent:  
Infiltration: **None** Pipe Seal Cond: **Sound**
